Power Quality Issues in Hospitals

Abstract: This paper describes power quality audits conducted at hospitals in Western Australia and Puerto Rico. Voltage and current measured at various points were used to assess the quality of the power used at both facilities. The main power quality problems found were voltage flicker, neutral currents, and harmonic distortion. Measurements of the total harmonic distortion (THD) were used to locate harmonic sources. Recommendations were made based on the results of each of the audits. Both studies serve as awareness for the importance of power quality in sensitive equipment found at hospitals. The power quality audits in this paper were part of the programs of study for students participating in the projects, which makes these efforts important pedagogical tools.

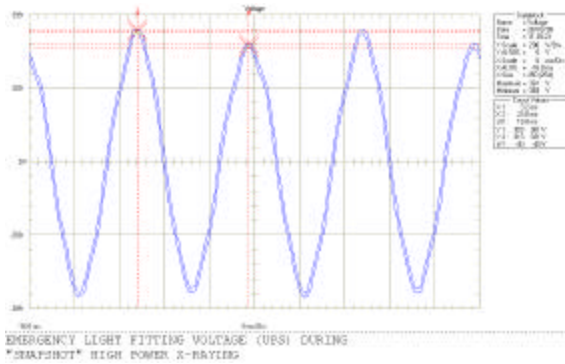
Figure 3. Emergency Lamp Voltage while Snappshot x-raying.

In order to investigate the cause of lamp flickering, the voltage and current of the lamps were monitored. Figure 3 shows the lamp voltage with UPS while snapshot x-raying.

The voltage waveform clearly shows a 50 Hz variation of 40 V.

As the lamps running from ES supply did not show any voltage fluctuations, it was recommended that all emergency lamps be supplied from the ES supply. However, considering the fact that in the event of loss of ES supply, the stand by generator take 2 minute to take up load some measures are required. For this purpose, our recommendation was to replace all emergency lamps in the operating theatres by their energy storage type counterparts. The Atco power pack model DBL 1120N-01 is one such lamps suitable for 2X36 W lamp fittings which would provide back up for 2 hours.

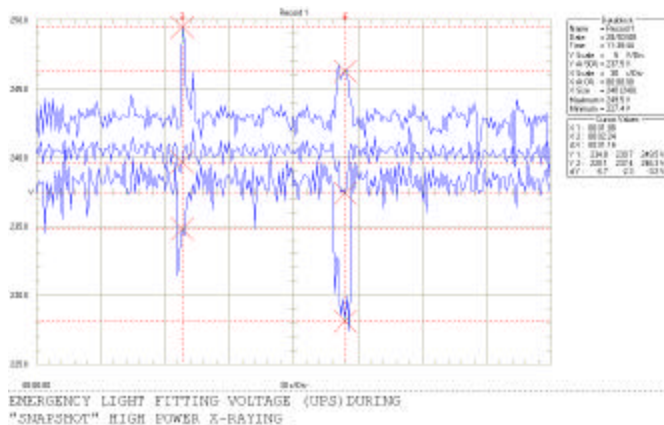
Figure 4. Lamp rms voltage over a 4 Minute Period.

Figure 4 shows the lamp r.m.s voltage over a 4 minute interval. In this period two x-raying snapshots were taken as shown in the Figure. The variation of peak voltage was measured to be equal to 40 V between two successive period. Figure 4 clearly indicates severe voltage fluctuations while x-raying using the UPS system. However, with the ES supply no voltage fluctuations were found.

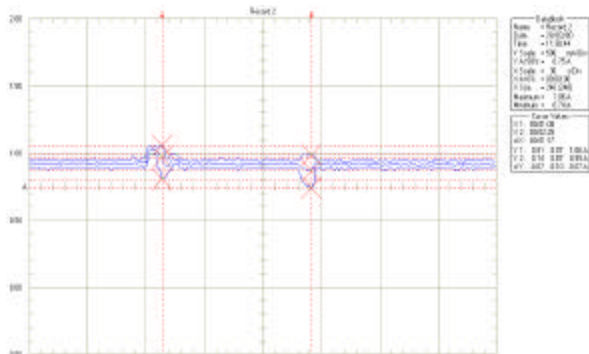
Figure 5. Lamp Current during the 4 Minute Period.

The current drawn by the lamp is shown in Figure 5.

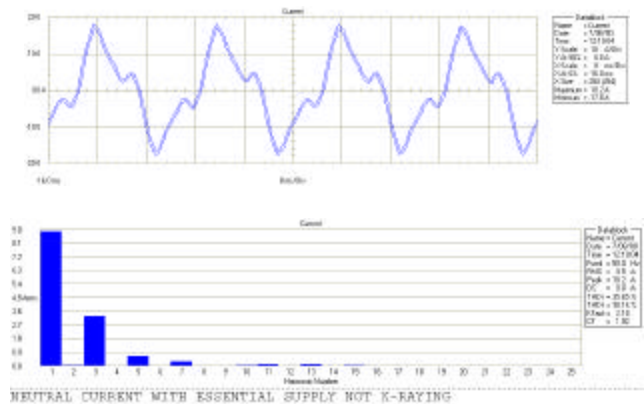
Figure 6. Neutral Current and its Spectrum.

Figure 6 shows the neutral current and its spectrum. The current waveform is severely distorted with a THD of 38.16% without x-raying from the ES supply.

It is interesting to note that the THDI of the neutral current did not worsened significantly while screening or snapshot x-raying. The other observations was that the THDI of the neutral current was 7% to 15% lower for the UPS supply than the ES supply. These observations and the high fundamental component of the neutral component proves that the high neutral current is not so much due to the no-linear loadings but due to phase load unbalance. An inspection of the circuit diagram of the Philips xraying equipment revealed plenty single phase equipment connected to the Red phase. The

single phase equipment includes dc power supplies, computers and monitors as well as blower motor for cooling of the x-ray tube. Most of this equipment produces large third harmonic current and hence the violation of the third harmonic limit. This also explains why the process of x-raying did not have much effect on the THDI of the neutral current. However, the third harmonic current violates the IEC 61000-3-2 standard.

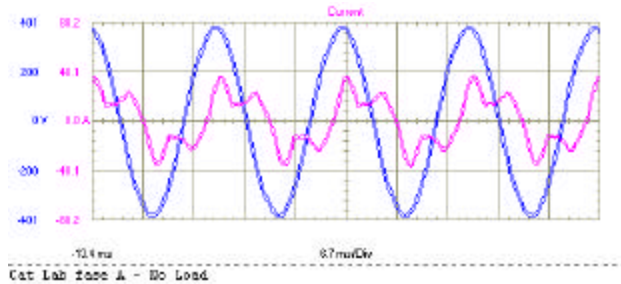
Figure 7. Catheterism equipment idle (phase A)

Fig. 7 shows the in-line voltage regulator and the C-Arm equipment (described in section II) in idle mode. A high degree of distortion is observed for the current, but the voltage presents only minimum distortion. Fig. 8 shows the harmonics present in the current for the same catheterism machine. There is a high degree of third harmonic present in this case, typical of magnetic devices. At this point the current drawn was around 20 A.

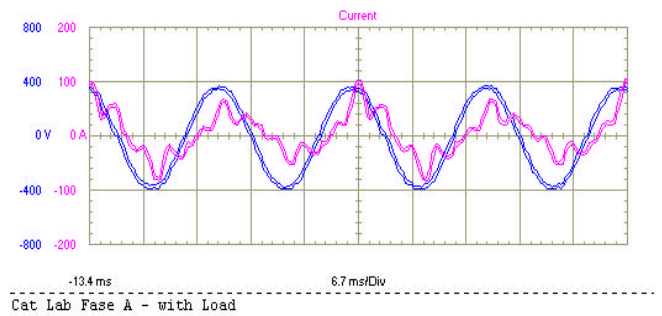
Figure 9. Catheterism Equipment operating (phase A)

In Fig. 9, the catheterism machine is operating. The current distortion resembles a step square wave. The steps follow a sinusoidal wave. This behavior agree with the way this

machine operates, were continuous x-ray "shoots" draw high current in steps. As with idle operation, there is minimal voltage distortion. The amplitude of current is almost twice in this case, but the distortion is very different. Fig. 10 is the corresponding frequency spectrum for the device's current. In this case the fifth harmonic is the largest, typical for switching devices. The current magnitude of the third harmonic is slightly reduced as compared to idle operation, and its percentage in the spectrum is significantly reduced since the total current magnitude has doubled.

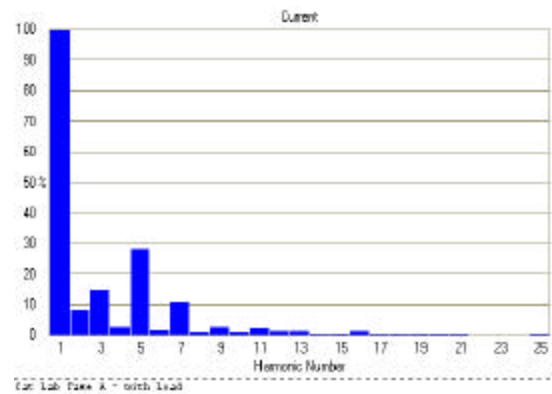
Figure 10. Harmonic strength for equipment operating (phase A)

The system is not affected by this distortion because as it can be seen in Fig. 2, there is a transformer in a wye-delta configuration. This configuration effectively isolates the triplen harmonics from the rest of the system. The only problem is in the transformer itself, where harmonics heat up the windings. This transformer presented some damage in its windings and is under schedule to be replaced. The deterioration was caused by the equipment harmonic distortion.
