Power Quality Observations at a Light Industrial Site

Hamish Laird, *Student Member, IEEE*, Simon Round, *Member, IEEE*, Richard Duke, *Member, IEEE*
Alister Gardiner.

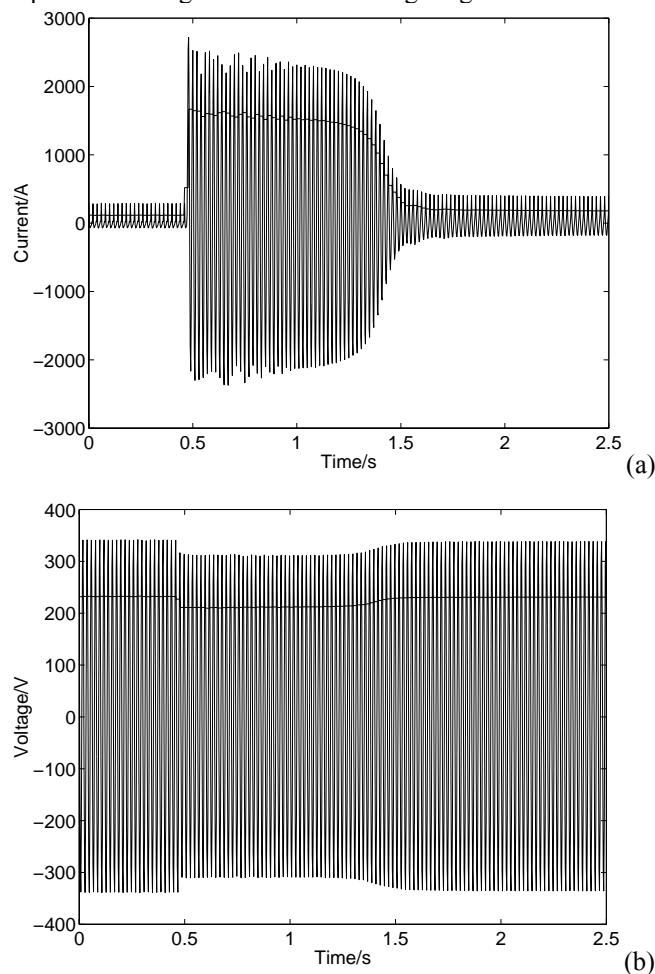
Figure 2. Induction Motor Start Transient (a) Motor Current (b) Supply Voltage (Instantaneous and RMS values)

water resistor starters to lower the start current. This large start current, Figure 2(a), causes a 10% drop in the supply voltage, (as shown in Figure 2(b)) which the customer has reported noticing as a flicker in the lighting.

The induction motor start transient typically causes a 10% drop in the site voltage. A solid-state or star-delta starter could lower the start current and so lower the voltage drop. The cost involved may not be justifiable as the motor start induced sag caused no reported problems other than the customer's concern about the "flick" in the lights. Another option to prevent the voltage drop is to control the motor run up with an adjustable speed drive. This again is an expensive option and is probably not worth pursuing. A more reasonable approach is to ensure the customer is aware of the possible consequences of the voltage dip, such as nuisance tripping and PLC malfunction. This awareness will ensure that any problems that the dips do cause will be noted.

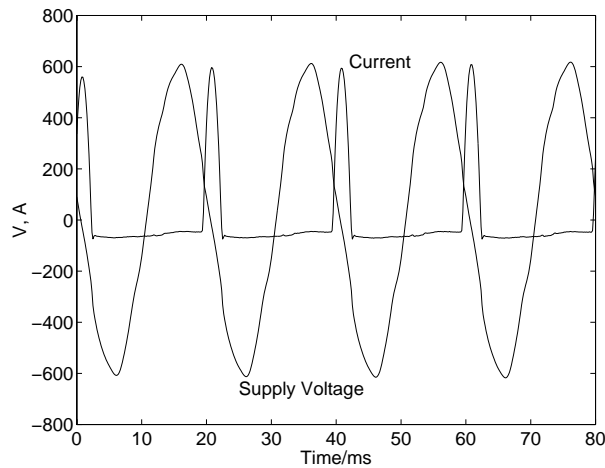
Figure 4. Induction Motor Heating Unit Current and System Line to Line Voltage

The units are half-wave controlled rectifiers having only one thyristor and they produce DC, odd and even harmonics in the AC current. The lack of half-wave symmetry indicates that there are even harmonics and a DC component present.

The DC current has impact on transformer operation as it produces a DC MMF that will offset the magnetising hysteresis of the transformer core. If the offset is large enough to drive the core sufficiently into saturation the magnetising current will increase and this could cause transformer overheating and possibly failure. As the rectifiers are connected line to line, the current has non-zero sequence triplen harmonic components that propagate through a star-delta supply transformer. Such harmonic currents may cause resonance that would not be excited by zero sequence triplen harmonics (produced by balanced harmonic loads) which are blocked by a star-delta transformer. The impact of the motor

The induction motor heater unit current harmonics are large and the presence of even harmonics is unusual. The apparent lack of problems that the DC component of the heater current causes is perhaps fortuitous as the resulting transformer MMF offset could cause transformer damage through saturation. No such damage has occurred and the transformer operating temperature during the site survey was 38 C. The fact that the heater units operate only when the site load is low means any adverse transformer heating from saturation is offset by reduced heating due to the low load. Configuring the rectifiers to produce a half wave symmetric current waveform would eliminate the DC current produced by the induction motor heaters. One way to do this is to reverse the phase connection of one of the induction motor heaters. The two heater units would then conduct in opposite half cycles and together would produce a half-wave symmetric waveform. This would decrease the peak current and remove the even harmonic currents. The current waveform would however not be half-wave symmetric at all times as the heating units are on occasion operated separately. However the maximum level of DC current flowing in the transformer would be lowered as DC current would flow only when one heater was operating.

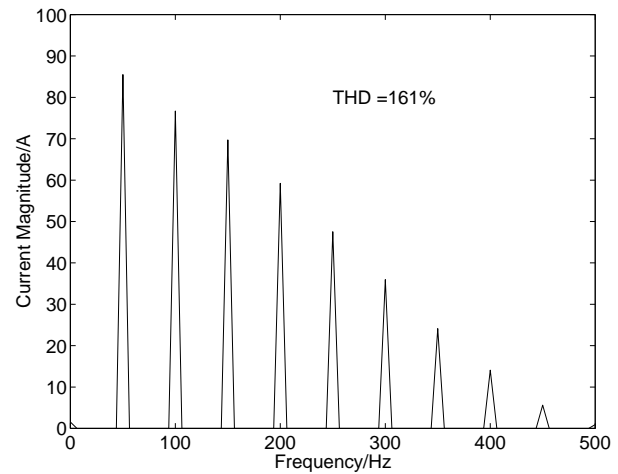
Figure 5. Induction Motor Heater Current Frequency Spectrum

The frequency spectrum of the heater current is shown in Figure 5. There is no DC component shown on the spectrum, as the current sensors are current transformers that are not capable of measuring the DC component. The presence of the DC current component was confirmed by on site measurement with a meter capable of DC current measurement. The even harmonic content is shown and the presence of these means that a system resonance at or near an even harmonic could be excited by this waveform. A current without even harmonics could not excite such a resonance.

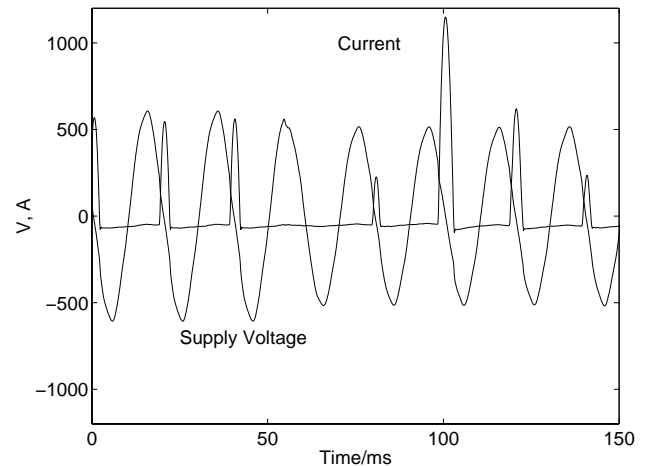
Figure 6. Induction Motor Heater Current and Supply Voltage during a Sag

heating units is apparent when a voltage sag occurs (as shown in Figure 6). The relatively small voltage reduction of 15% causes a large transient excursion with a peak of 1200A along with one missed conduction cycle.
