Power Quality Issues in Hospitals

Abstract: This paper describes power quality audits conducted at hospitals in Western Australia and Puerto Rico. Voltage and current measured at various points were used to assess the quality of the power used at both facilities. The main power quality problems found were voltage flicker, neutral currents, and harmonic distortion. Measurements of the total harmonic distortion (THD) were used to locate harmonic sources. Recommendations were made based on the results of each of the audits. Both studies serve as awareness for the importance of power quality in sensitive equipment found at hospitals. The power quality audits in this paper were part of the programs of study for students participating in the projects, which makes these efforts important pedagogical tools.

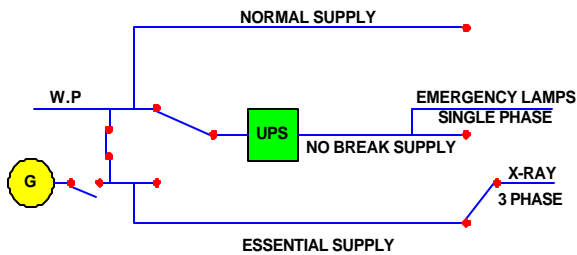
The essential supply is backed up by an emergency generator. Figure 1 shows a simplified electrical layout of the hospital's cardiovascular operating theatres.. It is to be noted here that a single phase voltage supply all emergency lighting and a three phase supply feeds the X-ray equipment in the cardiovascular operating theatres of the hospital.

The interchange circuit breakers in Fig.1 are controlled automatically according to the availability of various supplies. In case of a utility failure all circuit breakers to the left of the UPS change over and normal supply is discontinued.

Figure 1. Simplified Electrical Layout of the Cardiovascular Operating Theatres

The X-ray equipment in the operating theatres at the hospital is supposed to be normally run from the UPS system. However, due to light flickering while being supplied by the UPS, the X-ray machine was supplied by an essential power supply instead. Hence in a blackout situation the X-ray equipment would loose power until the start-up of the diesel generator. During the two minute change over the operating theatre staff are unable to monitor patients condition. The neutral current on the essential supply is found to be large and have very high total harmonic distortions. The X-ray machine operates on two modes:

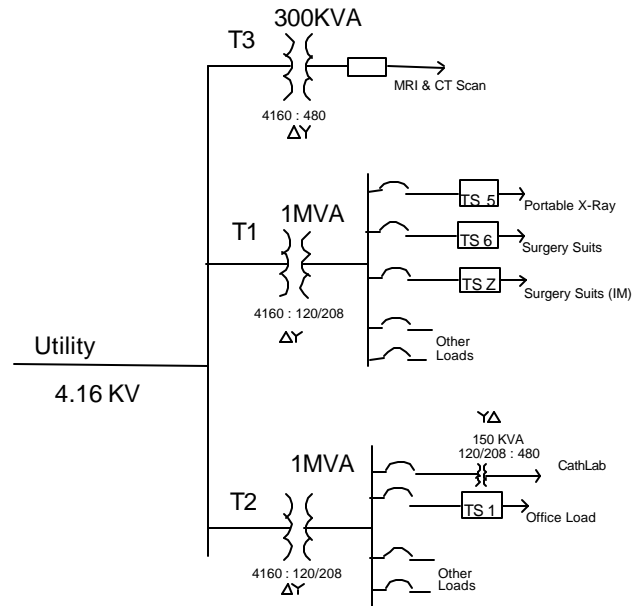
The peak load at Bella Vista Hospital (BVH) is 1 MVA, as measured by the local utility. The load is distributed among thirty-seven circuits, using two 1 MVA dry-type transformers. Fig. 2 shows the main circuits of the system. Service from the Puerto Rico Electric Power Authority (PREPA) comes from a 4.16 kV feeder. The hospital is located in a residential area over the top of a hill.

Figure 2. Pictorial for the hospital's electrical system

The first step of the power quality audit was an inspection of the hospital's electrical system. Even though numerous renovations had been made in the last fifteen years, a one-line diagram of the electrical system was not available at BVH. A complete schematic of the system, shown in Fig. 2, was developed using the information gathered after a thorough inspection of the system.

The system is not affected by this distortion because as it can be seen in Fig. 2, there is a transformer in a wye-delta configuration. This configuration effectively isolates the triplen harmonics from the rest of the system. The only problem is in the transformer itself, where harmonics heat up the windings. This transformer presented some damage in its windings and is under schedule to be replaced. The deterioration was caused by the equipment harmonic distortion.
